**Flood Control Project Maintenance  
Levee Inspections**

**Fall 2013 Levee Maintenance Deficiency Summary Report**

**Sutter Maintenance Yard Murphy Slough at M&T Ranch**

**Levee Inspection Report By Mile - Fall 2013**

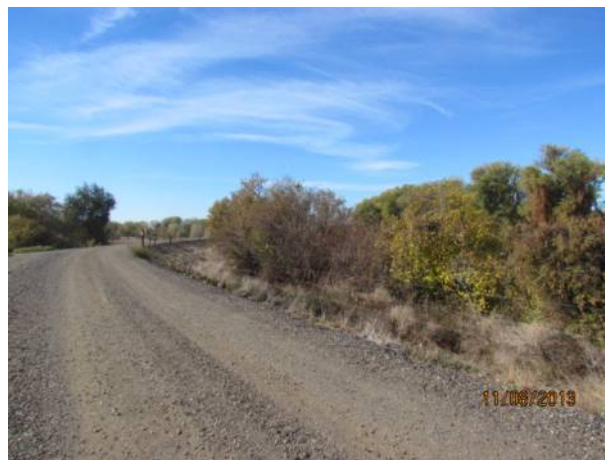
rduffey\_f\_20131118\_178.JPG

Levee Mile Report Line	4
Start Levee Mile	0.00
End Levee Mile	0.09
Location	Water Side
Category	Earthen Levee
Item	Vegetation

View of the elderberries along the waterside slope.

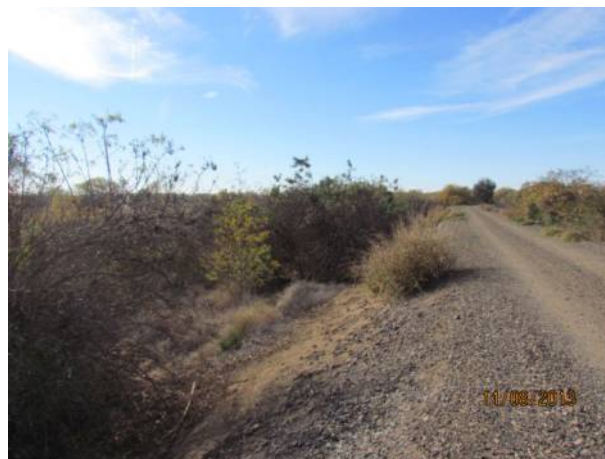
rduffey\_f\_20131118\_176.JPG

Levee Mile Report Line	5
Start Levee Mile	0.00
End Levee Mile	0.09
Location	Land Side
Category	Earthen Levee
Item	Vegetation

View of the elderberries along the landside toe.

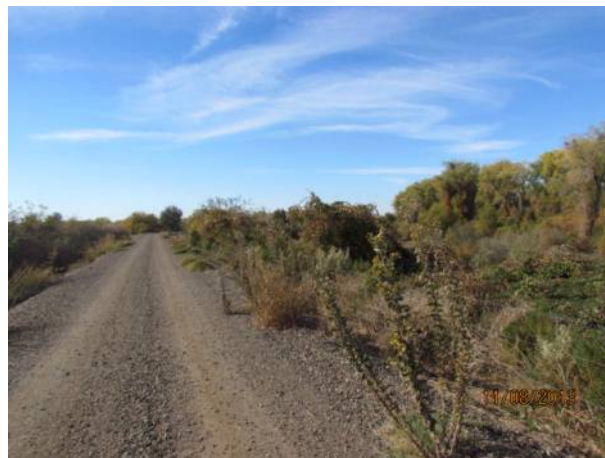
rduffey\_f\_20131118\_177.JPG

Levee Mile Report Line	6
Start Levee Mile	0.00
End Levee Mile	0.20
Location	Water Side
Category	Earthen Levee
Item	Vegetation

View of the vegetation along the waterside slope.

DWR ID: DWR_NA0014_01_s_2012_4										
6	0.00	0.20	Earthen Levee	Vegetation	WS	M Ma	V2 : Remove the wild growth other than native grasses from the levee slopes.	39.666988 ° -121.960993 °	39.666988 ° -121.960993 °	5 Y
DWR ID: DWR_NA0014_01_s_2012_5
